## Flooding In Tutbury and Anslow in June & July 2023

Investigation under Section 19  
of the Flood and Water Management Act 2010

Document Ref: S19 Investigation - Tutbury and Anslow - July 2023					
Revision	Date	Description	Originated	Checked	Authorised
V0.1	24/06/24	Draft for RMAs	CA	JC	
V0.2	05/07/24	RMA amendments	CA	JC	
V0.3	11/07/24	SCC amendments	CA	JC

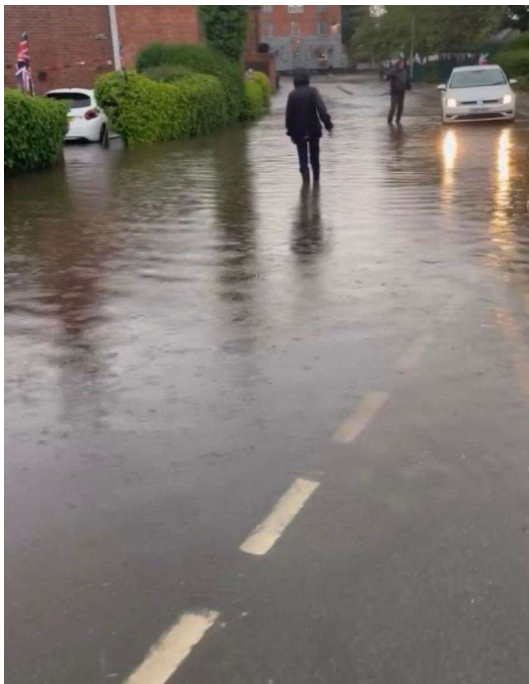
Figure 1 - Main St, Anslow

In Anslow floodwater accumulated in the middle of the village in Main Road and Bushton Lane. The significant depth of water caused flooding to residential properties and businesses.

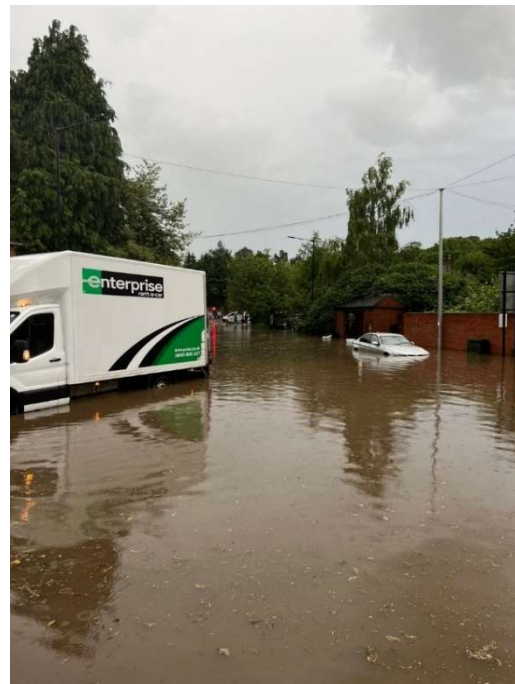
Figure 2 - Duke St, Tutbury

In Tutbury, floodwater flowed down Ludgate Street, Fishpond Lane, and Castle Street, accumulating to significant depths in Duke Street. There were further flows down High Street and Monk Street, where floodwater accumulated in Bridge Street. On Cornmill Lane flows from a separate catchment accumulated in front of the terraced properties.

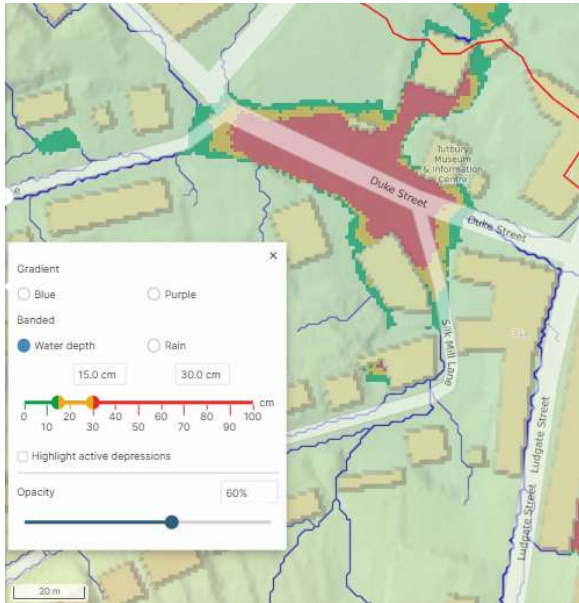
At Duke Street, the level can reach approximately 65cm, with a volume of 250m<sup>3</sup>.

Figure 6 – Duke St: Depression Storage. Max Depth: 65cm, Volume: 250m<sup>3</sup>

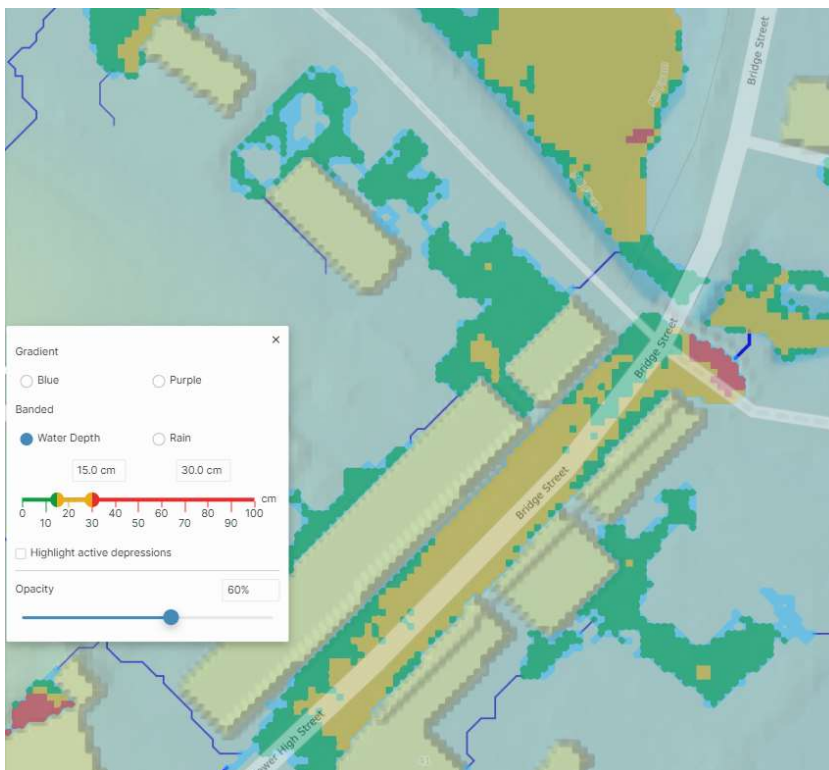
At Bridge Street, the level can reach approximately 24cm, with a volume of 160m<sup>3</sup>.

Figure 7 - Bridge St: Depression Storage. Max Depth: 24cm, Volume: 160m<sup>3</sup>

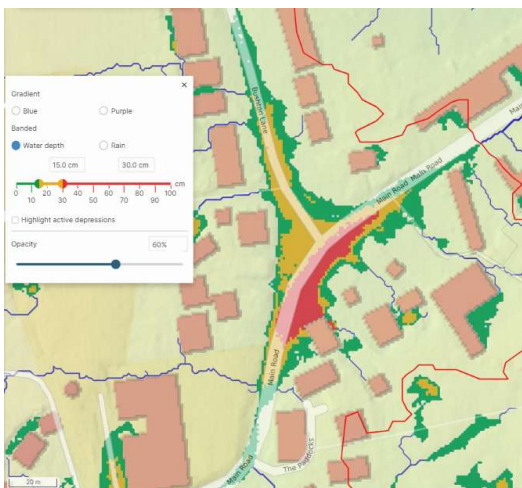
On Main Road, the level can reach approximately 65cm, with a volume of 680m<sup>3</sup>.

Figure 13 - Depression Storage. Max Depth: 65cm, Volume: 680m<sup>3</sup>

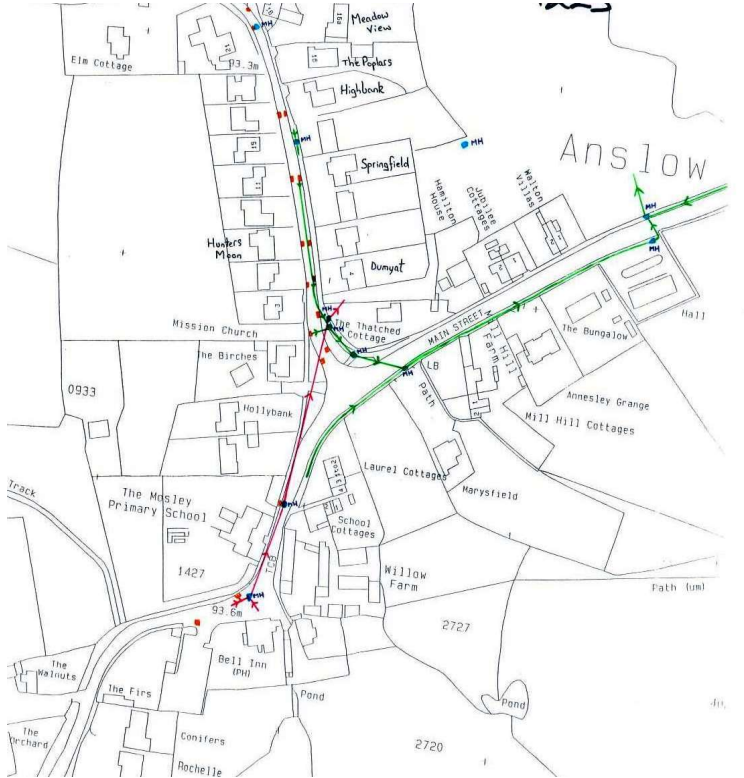
Figure 17 - Anslow drainage drawing

There are two main drainage networks in Anslow, as shown in Figure 17.

An older network with less capacity is shown in red, and a newer network is shown in green. Both discharge to an unnamed ordinary watercourse to the north of the village.

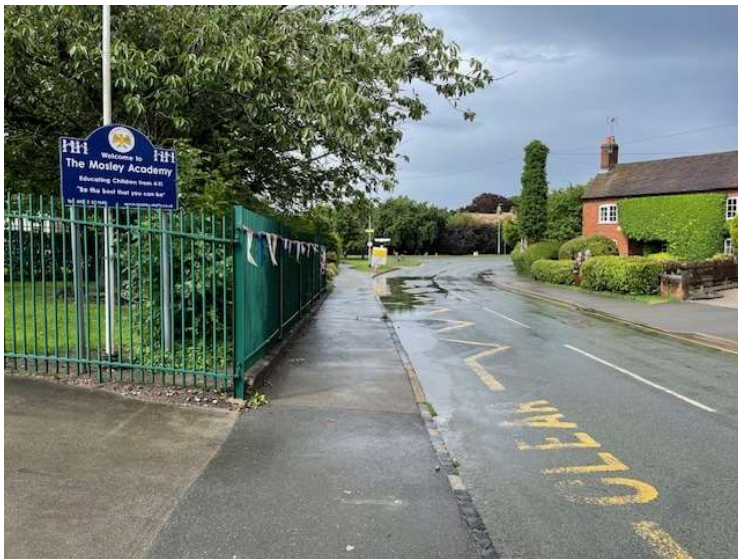
Figure 18 – Flooding from gully outside The Mosley Academy

Specific issues were identified with water flooding out of gullies outside the Bell Inn and the Mosley Academy, and also within properties.

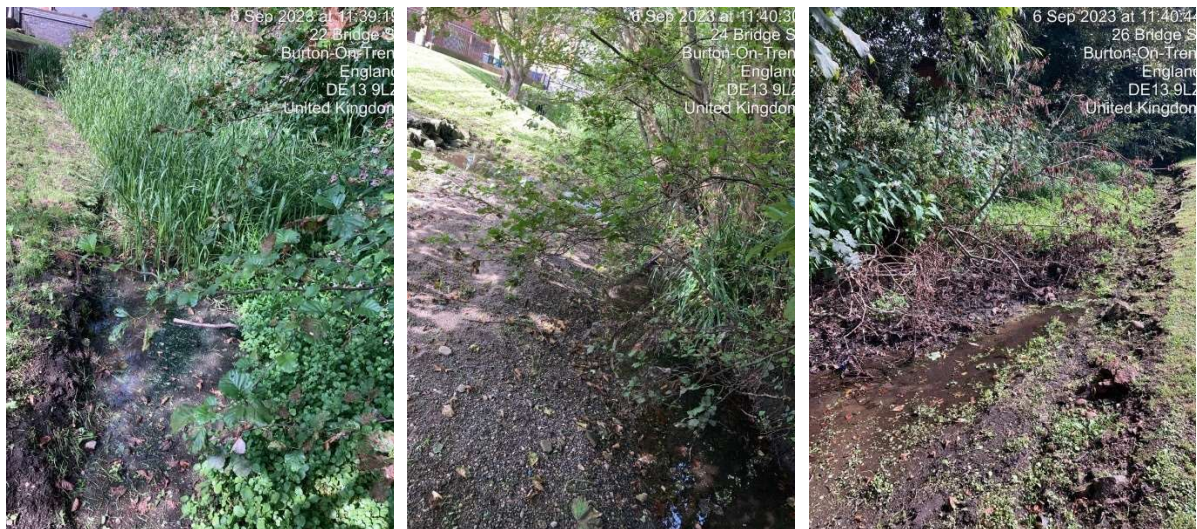
Figure 21 - Images of silt within the watercourse (Mill Fleam)

Severn Trent Water carried out checks on their network and found no area of concern within the network. They found the watercourse (Mill Fleam) around the outfalls to be heavily silted, which they believed could have an impact in heavy storm conditions.

The Environment Agency has confirmed that a maintenance assessment will be undertaken for Tutbury Mill Fleam. The asset performance team are still undertaking a maintenance assessment to see if any works are required. If work is identified, they will then have to bid for funding and have that allocated before any work could be undertaken.

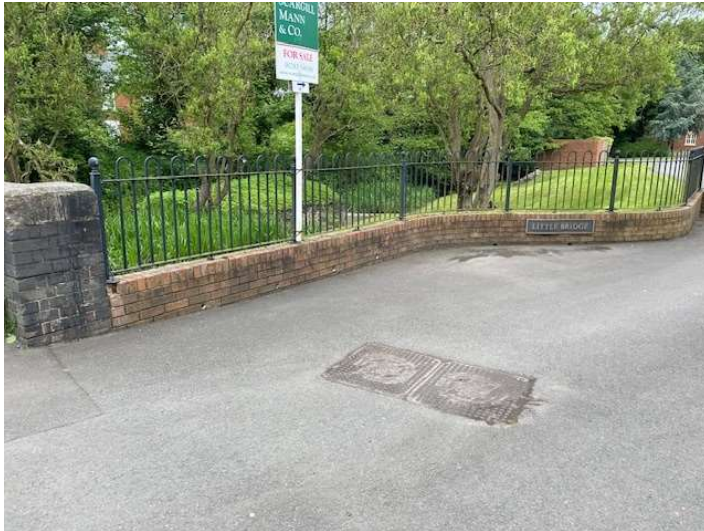
*Figure 23 – Feature potentially holds back water*

One way to reduce the impact of flooding is to review the natural flow routes and allow floodwater to flow away more easily without building up to such depths.

This may be achieved by re-profiling the ground, removing obstructions, or raising gates or fences to allow water to flow underneath.

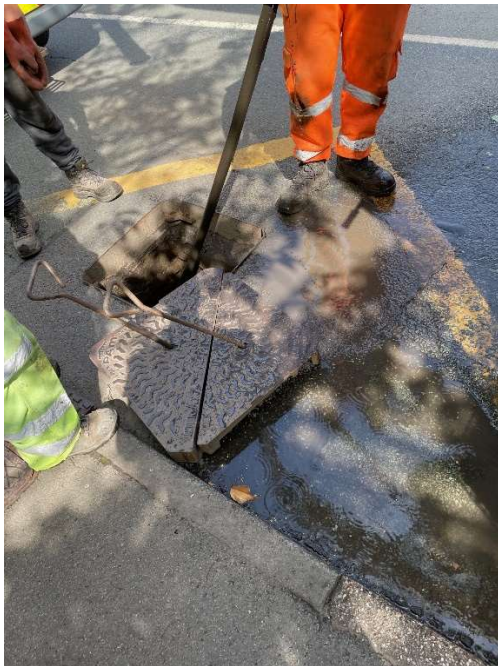
The networks shown in Figure 17 were jetted and inspected with CCTV.

A defect was identified in the red network adjacent to the Bushton Road junction, and this was subsequently repaired.

*Figure 24 - Systems jetted*

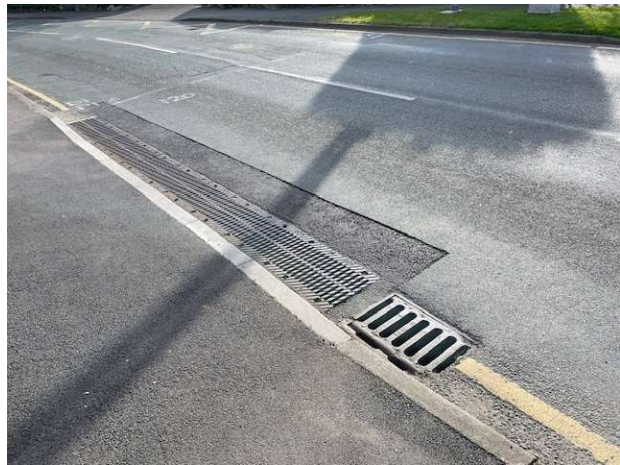
*Figure 25 - Additional drainage installed*

A new Birco drain was installed to increase the inlet capacity to the green network.

A new connection was made from the red network to the green network to provide additional resilience in case the capacity of the red network is exceeded.
