Guardrail, deterrent paving and signage improvements to restrict pedestrian route across Radford Bank Bridge

Refurbishment and drainage improvements to Radford Bank Bridge

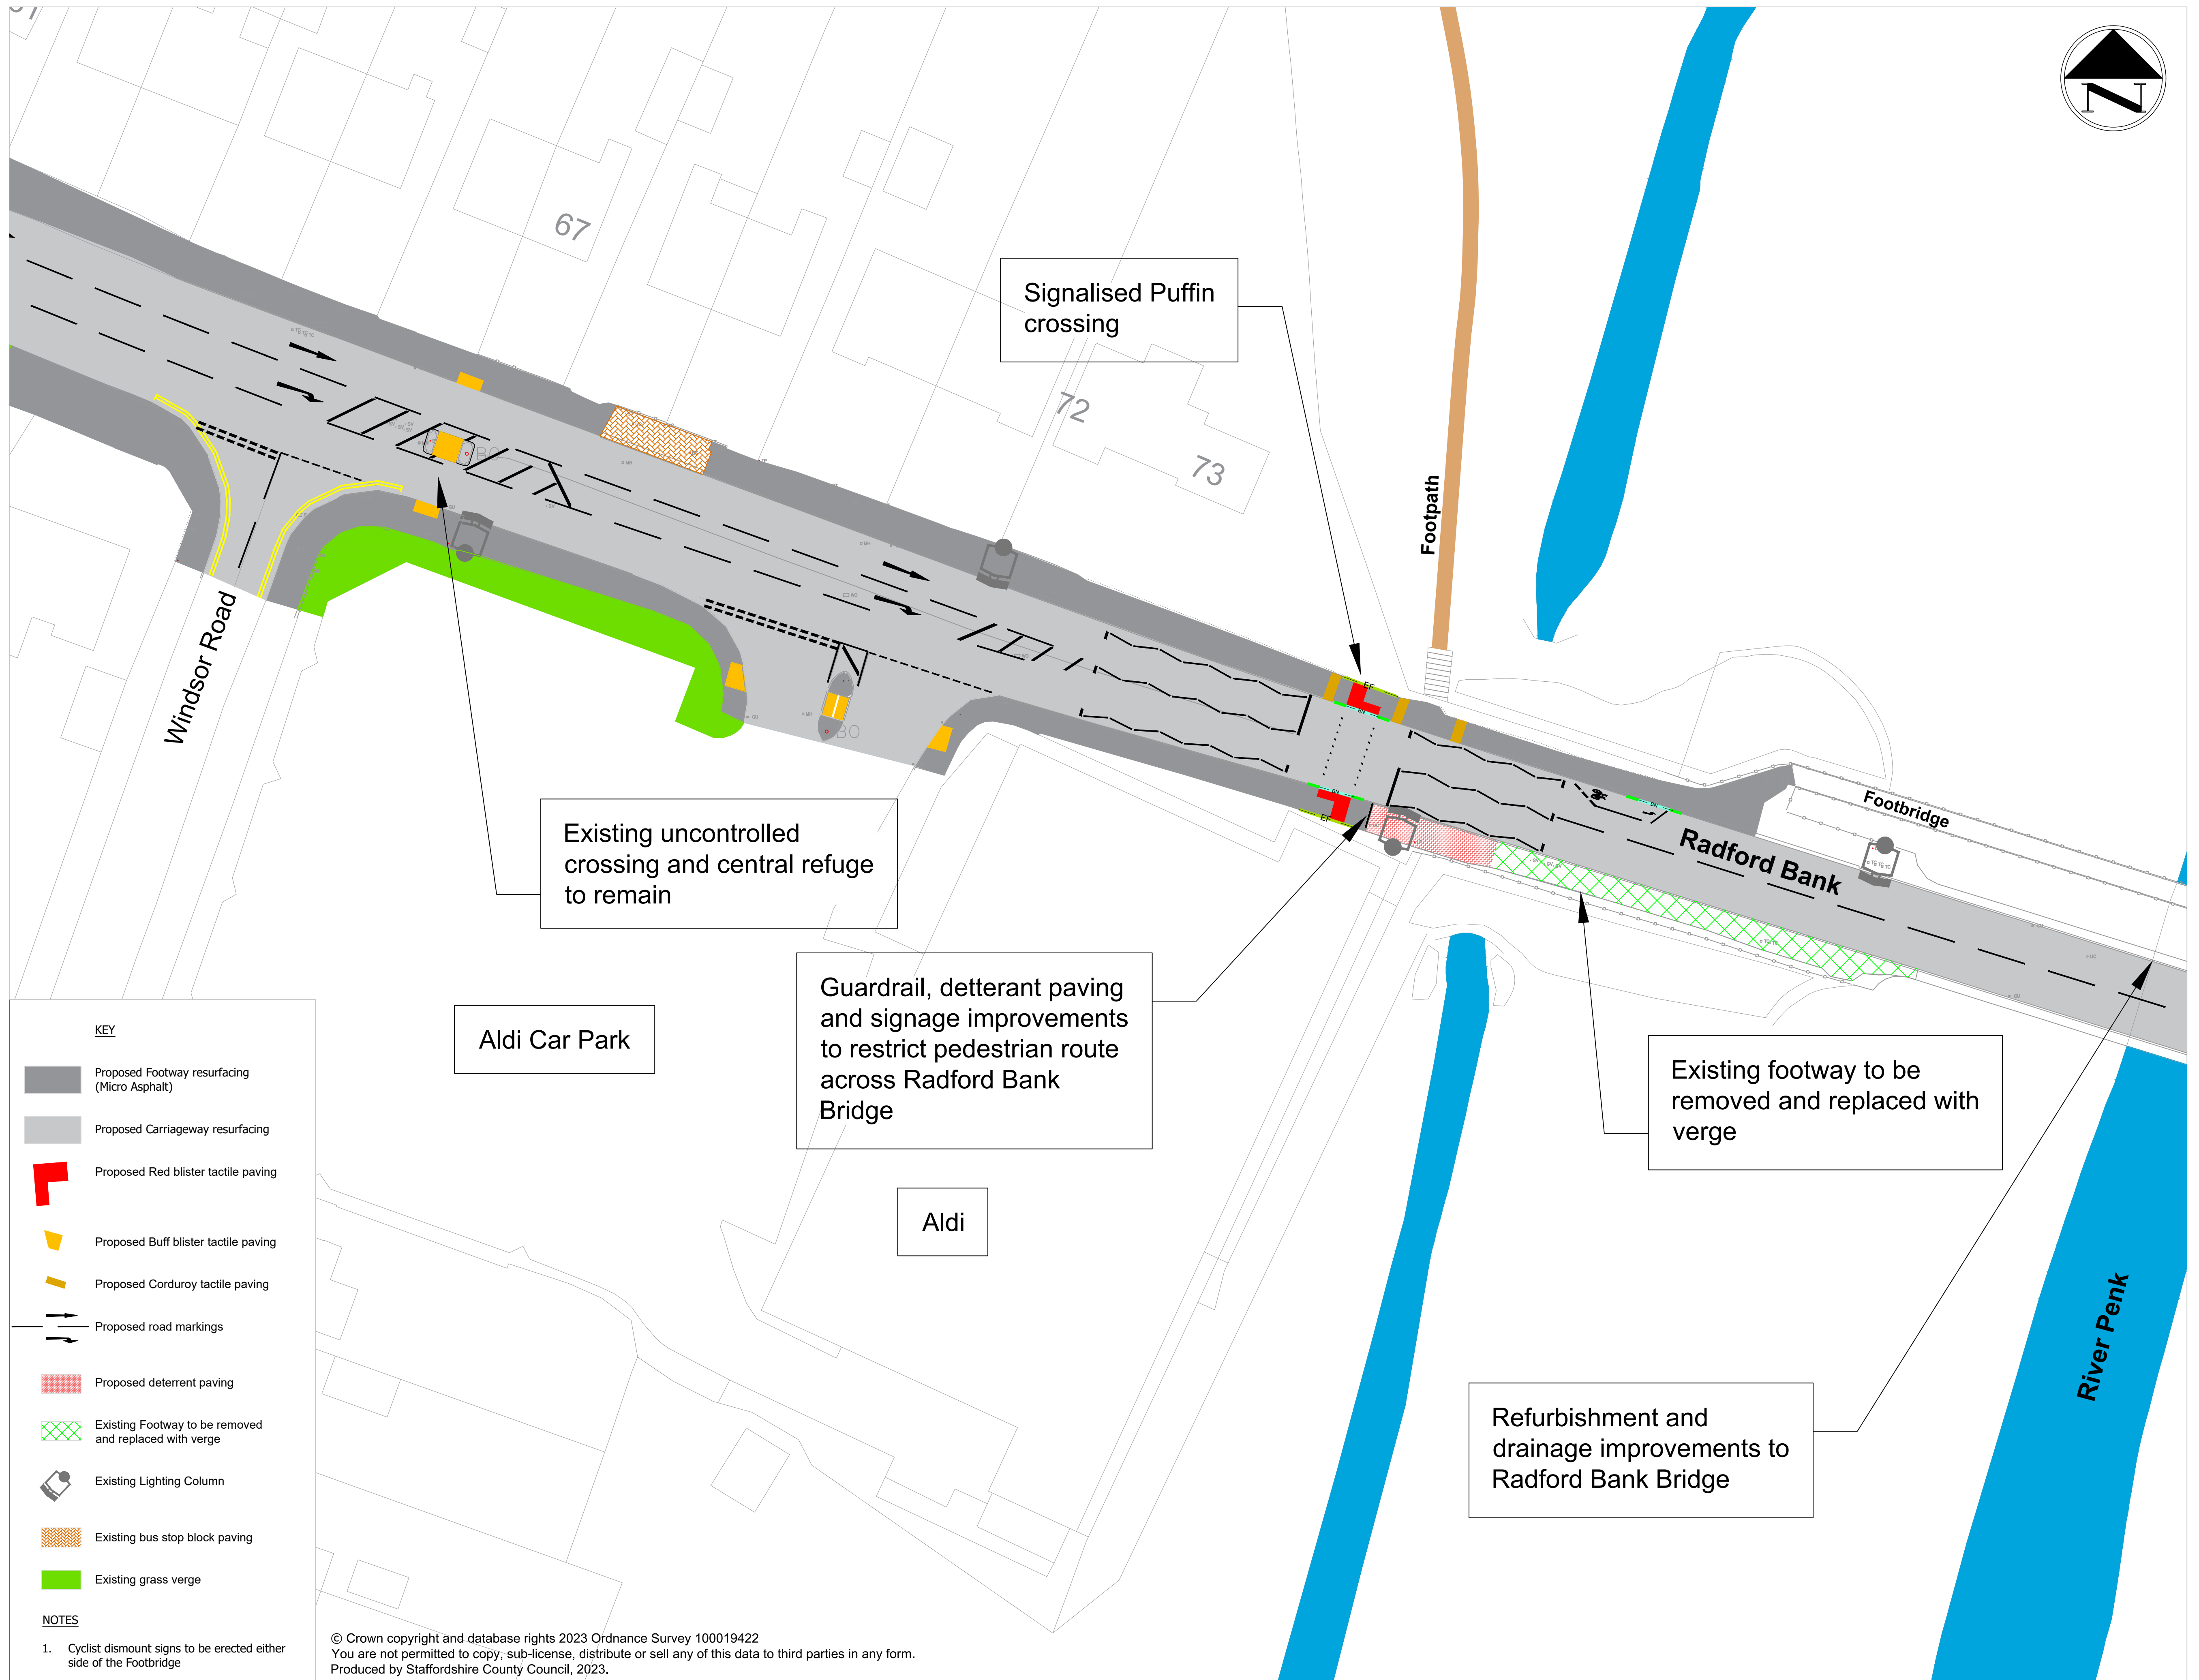
1. Cyclist dismount signs to be erected either side of the Footbridge

Signalised Puffin crossing

Existing uncontrolled crossing and central refuge to remain

Existing footway to be removed and replaced with verge
