## Flooding In Tutbury and Anslow in June & July 2023

Investigation under Section 19  
of the Flood and Water Management Act 2010

Document Ref: S19 Investigation - Tutbury and Anslow - July 2023					
Revision	Date	Description	Originated	Checked	Authorised
V0.1	24/06/24	Draft for RMAs	CA	JC	
V0.2	05/07/24	RMA amendments	CA	JC	
V0.3	11/07/24	SCC amendments	CA	JC

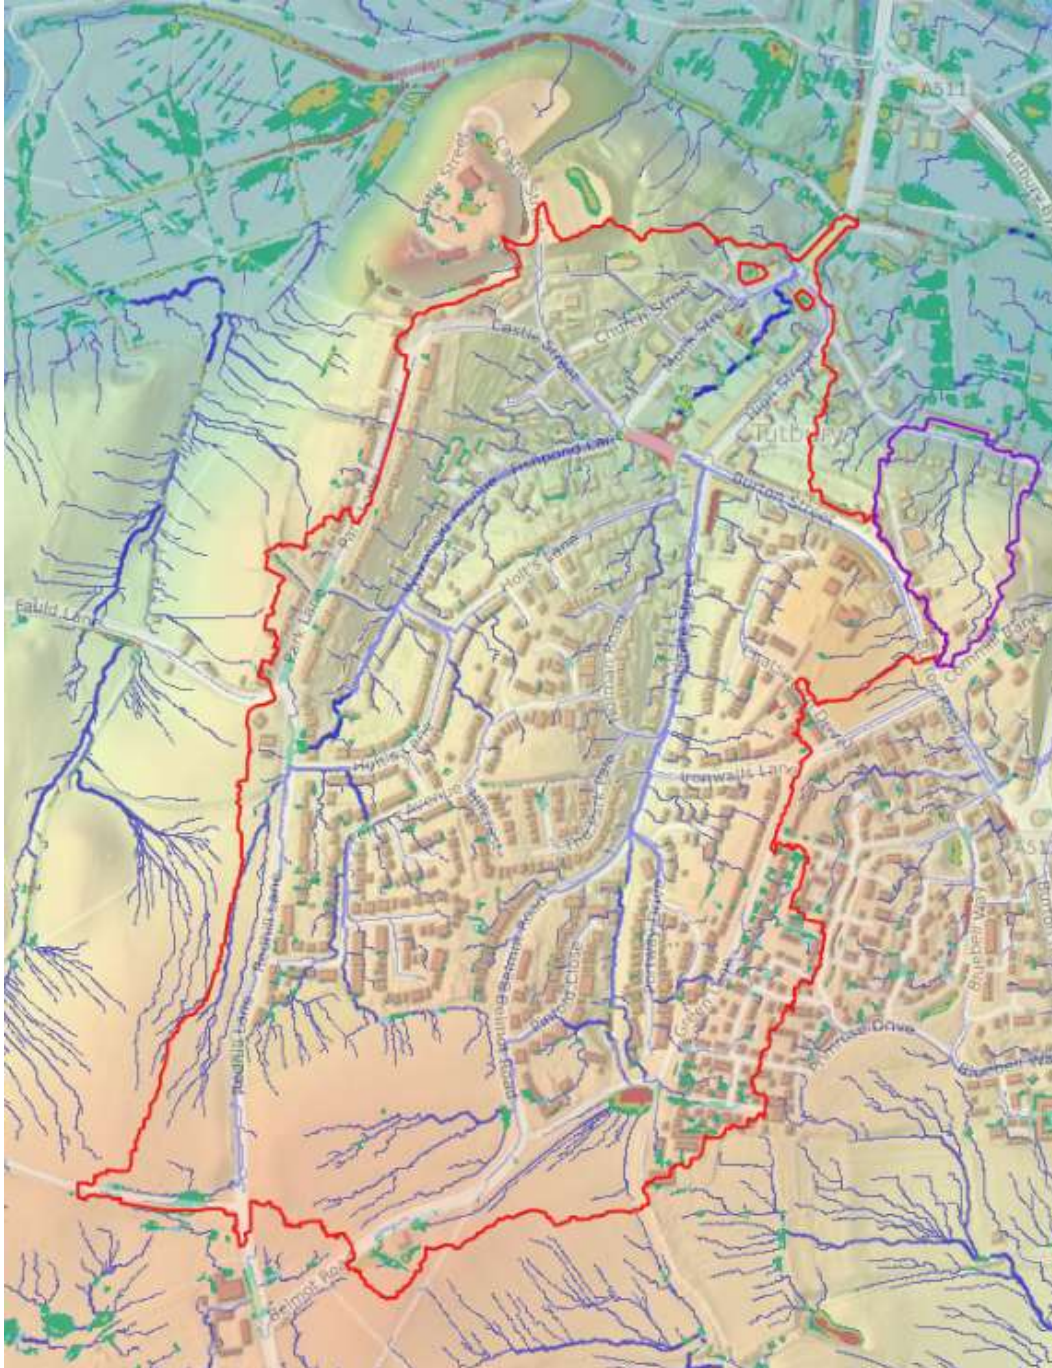
Figure 5 - Tutbury Catchment (red) Bridge Street: 77ha; Catchment (purple) Cornmill Lane: 4ha

The catchment area draining towards Bridge Street is approximately 77ha.

Assuming no infiltration, rainfall of 20mm across the catchment would generate a total volume of approximately 12,500m<sup>3</sup>.

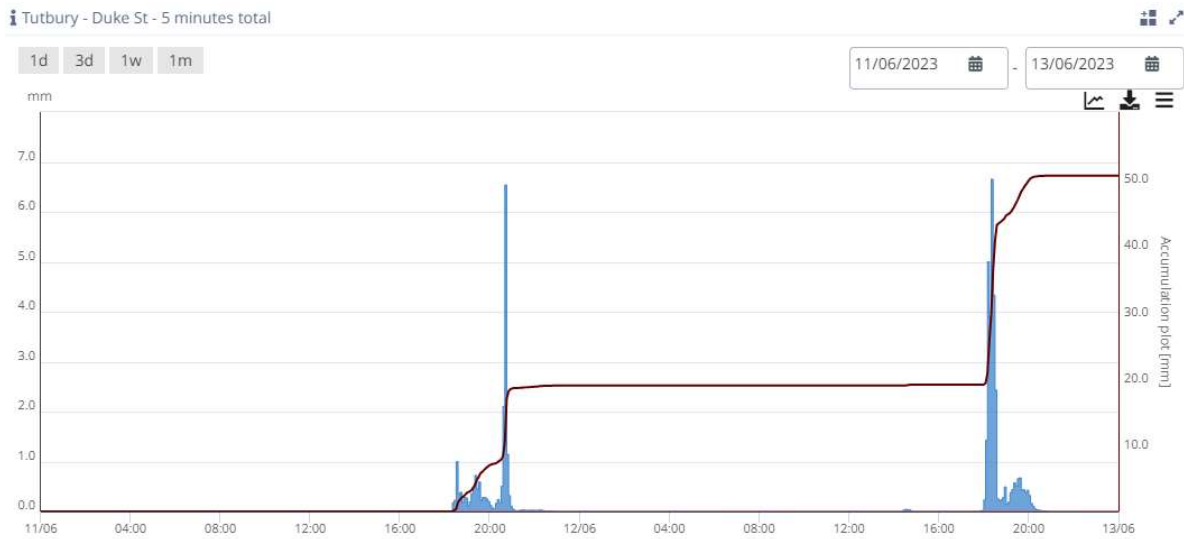
Figure 8 - Rainfall Rate and Accumulation 11/06/23 and 12/06/23

In each event between 20mm and 30mm of rain fell in 30 to 40 minutes. The estimated return period is in the range of 1 in 10 to 1 in 50 years.

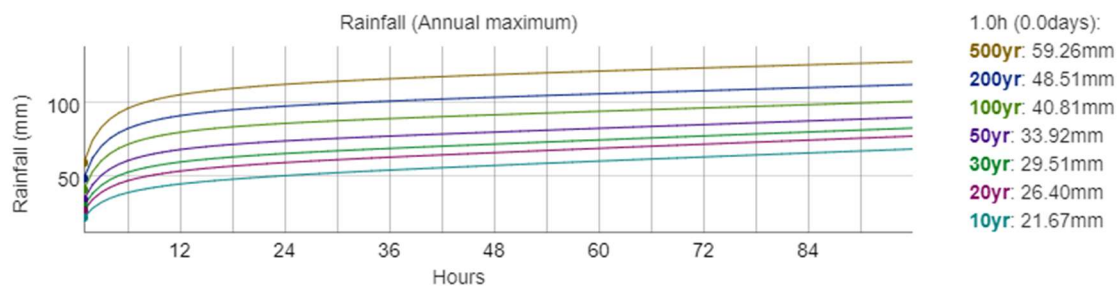
Figure 10 - Depth Duration Frequency Curves - Values for 1 hour duration

Note that Figure 10 shows the corresponding return periods for a 1 hour duration storm. It is more difficult to estimate a precise return period for storm durations lower than this.

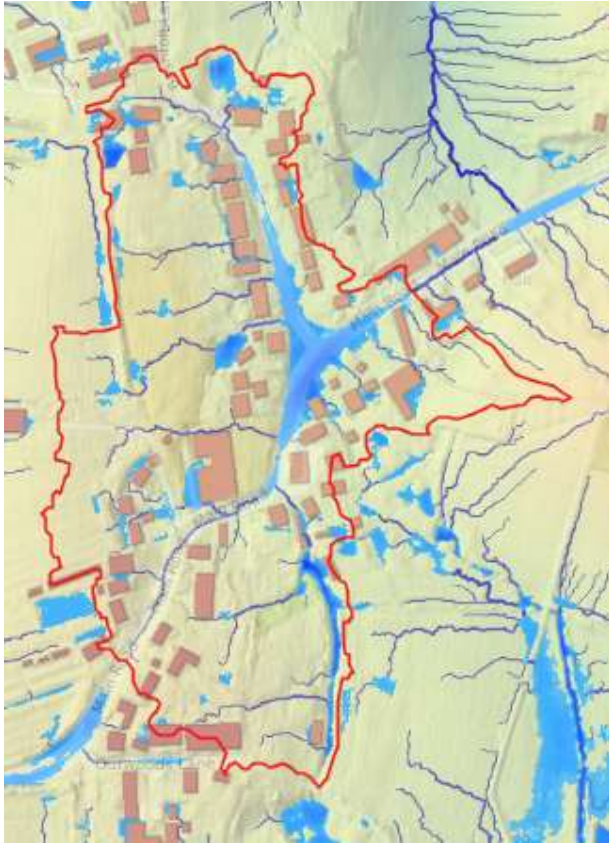
Figure 12 - Anslow Catchment: 9ha

The catchment area draining towards Main Road is approximately 9ha.

Assuming no infiltration, rainfall of 20mm across the catchment would generate a total volume of approximately 1800m<sup>3</sup>.

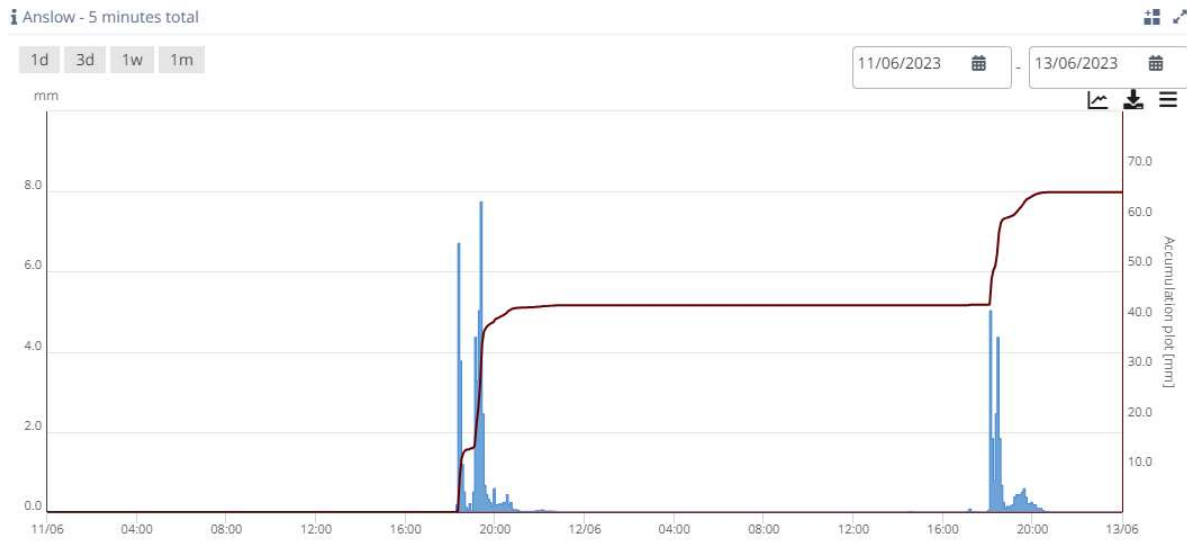
Figure 14 - Rainfall Rate and Accumulation 11/06/23 and 12/06/23

In each event between 20mm and 30mm of rain fell in 30 to 40 minutes. The estimated return period is in the range of 1 in 10 to 1 in 50 years.

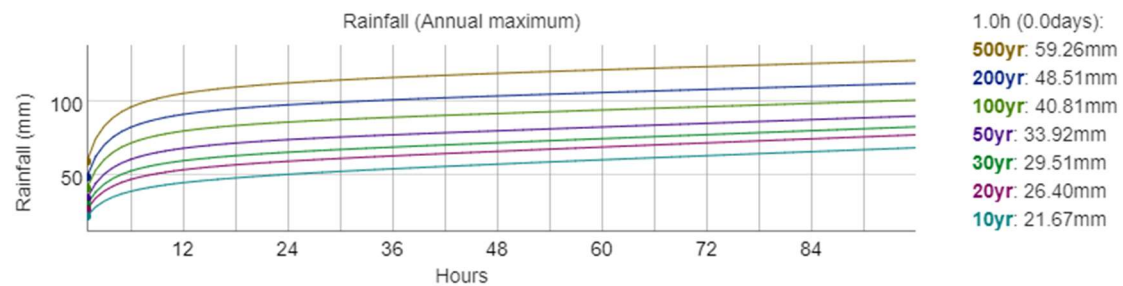
Figure 16 - Depth Duration Frequency Curves - Values for 1 hour duration

Note that Figure 16 shows the corresponding return periods for a 1 hour duration storm. It is more difficult to estimate a precise return period for storm durations lower than this.

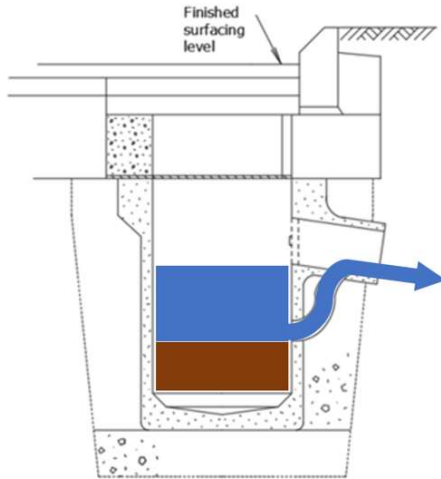
**Properly Functioning Gully**

Some silt at the bottom

Water sitting up to the outlet level.

During dry periods the water may evaporate but in wet weather it is normal to have some water.

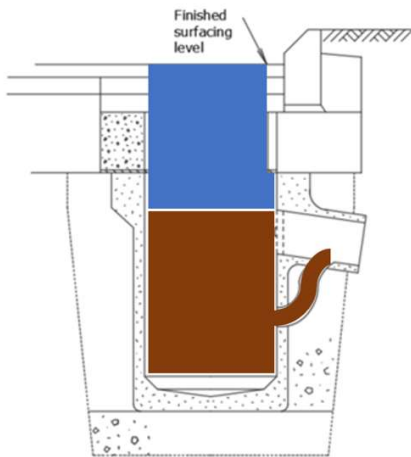
**Blocked Gully**

Silt level has risen significantly and blocked the outlet pipe and rodding eye outlet.

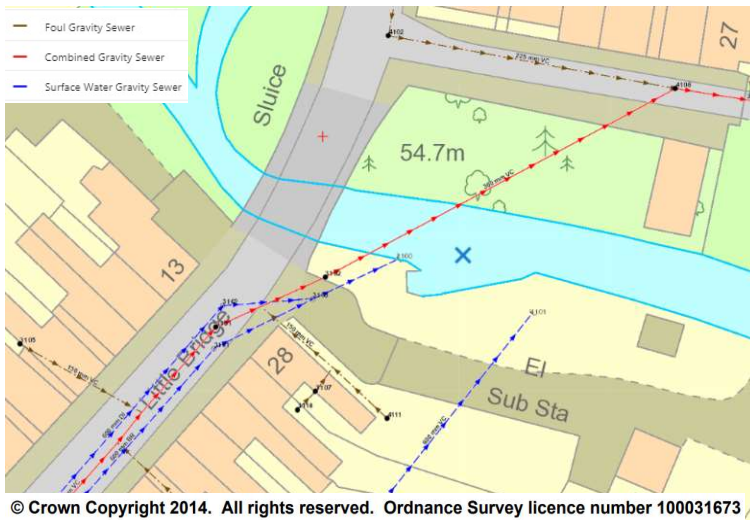
Figure 20 - Plan showing Severn Trent outfalls into the Mill Fleam

“Severn Trent has carried out investigations on their assets that outfall into the Mill Fleam in the area as marked on the plan below. Severn Trent has checked and confirm their outfalls into the Mill Fleam are clear. However, the watercourse in this area has been found to be heavily silted and is likely to restrict flow from Severn Trent surface water pipe network and outfalls into the Mill Fleam in heavy storm conditions. This would also have an impact on flow within the Mill Fleam.

Severn Trent has confirmed that their surface water pipe network and outfalls are as mapped according to their records.”

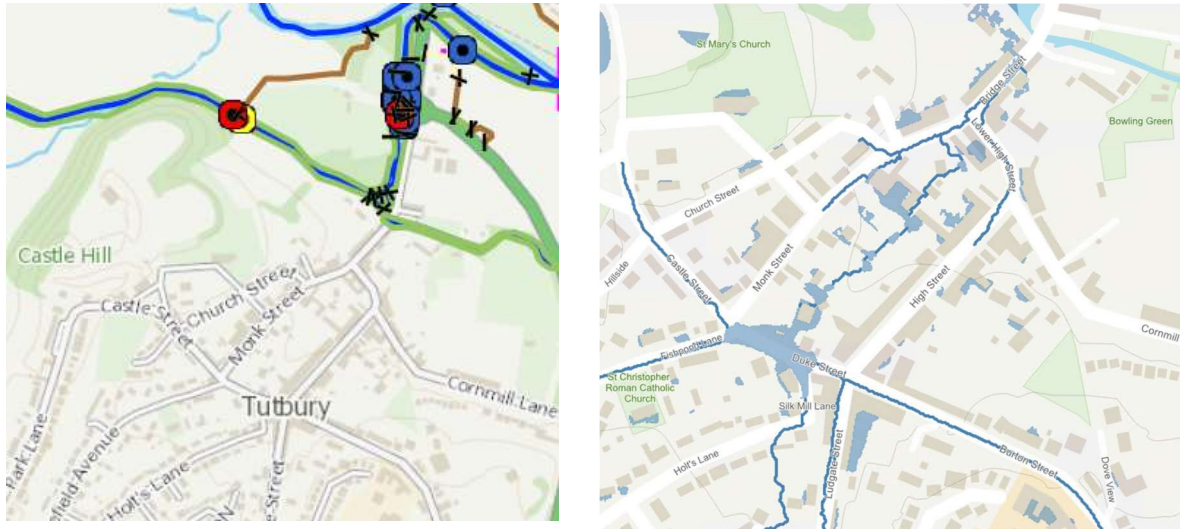
Figure 22 - EA Assets on Mill Fleam

We have investigated our Environment Agency assets on Mill Fleam and they are all up to date with their scheduled inspections, operational, and maintenance checks.

Environment Agency outfalls and screens in this area undergo an operational check every month, with the last check being completed on the 4th of July. No defects or comments were raised by the field team. They are inspected annually, with the last inspection being in December 2022.

Any defects raised have been actioned and completed prior to the flooding on the 8th of July.
